Fractography of Advanced Structural Ceramics: Results From The VAMAS Round Robin Exercise

Jeffrey J. Swab and George Quinn

ARL-TR-656

December 1994

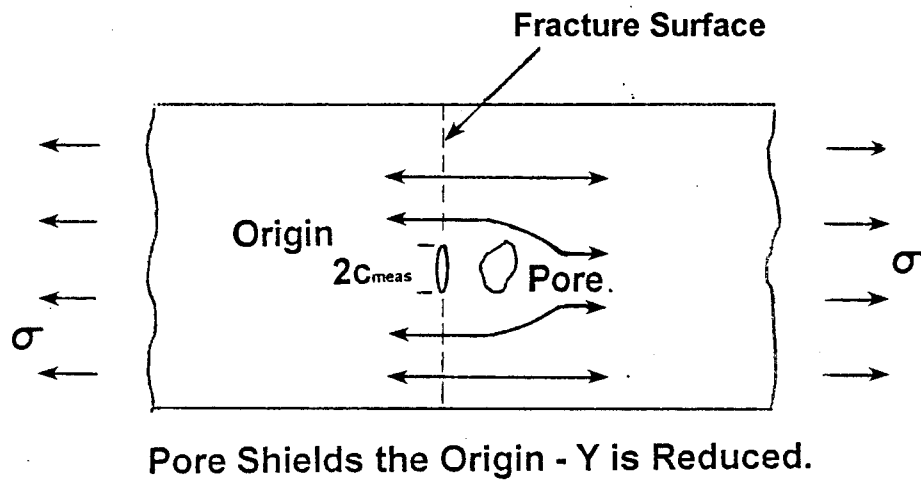
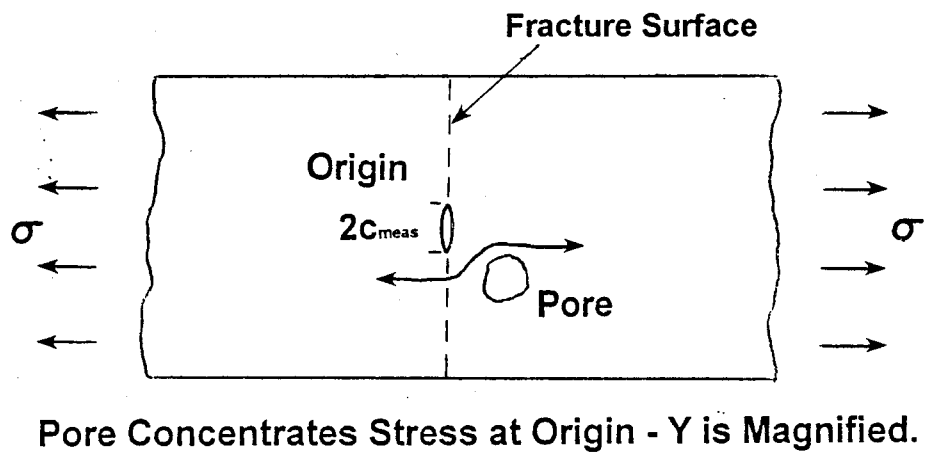
Figure A2.5 Discontinuities in the vicinity of the fracture origin can increase or decrease the stress intensity (Y) and result in c_{calc} being either an over- or underestimate of c_{meas} .

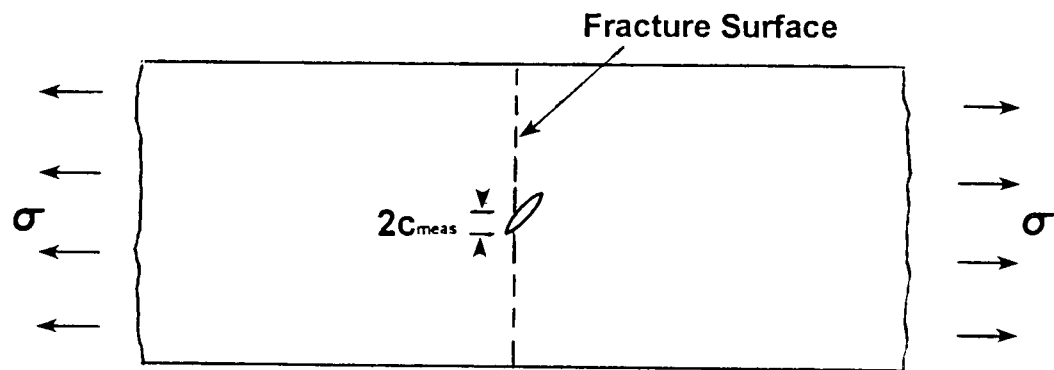
Figure A2.6 The origin may be truncated on the fracture surface, and its size, c_{meas} , may be underestimated during the fractographic analysis.
